**Gorst Creek - Bremerton Auto Wrecking  
Landfill  
Preliminary Assessment Report  
Port Orchard, Washington  
TDD: 02-10-0005**

Superfund Technical Assessment and Response Team

**GORST CREEK - BREMERTON AUTO WRECKING LANDFILL  
PRELIMINARY ASSESSMENT REPORT  
PORT ORCHARD, WASHINGTON**

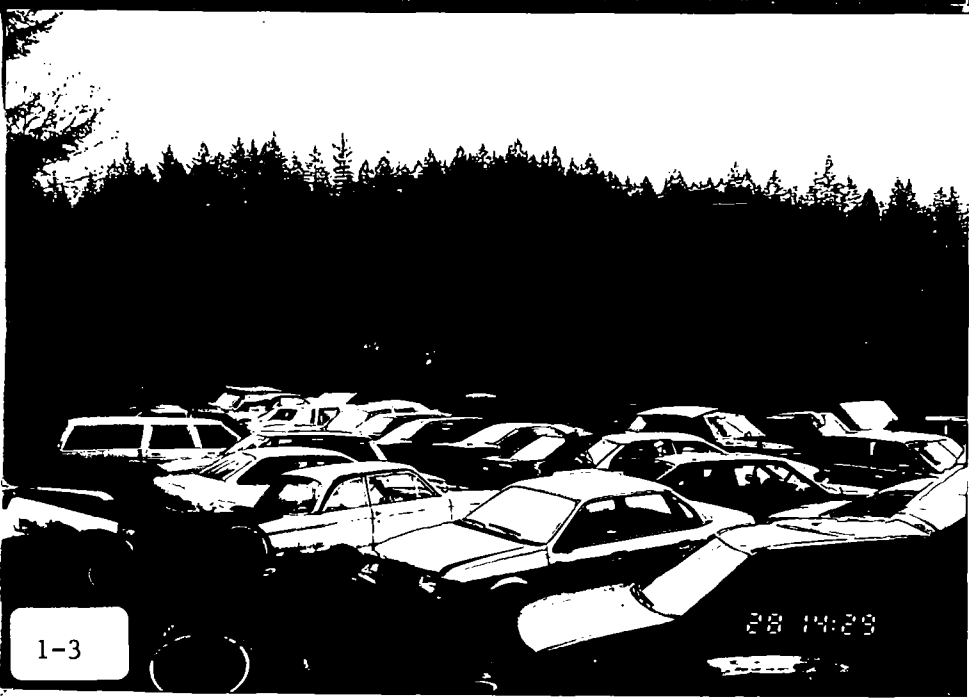
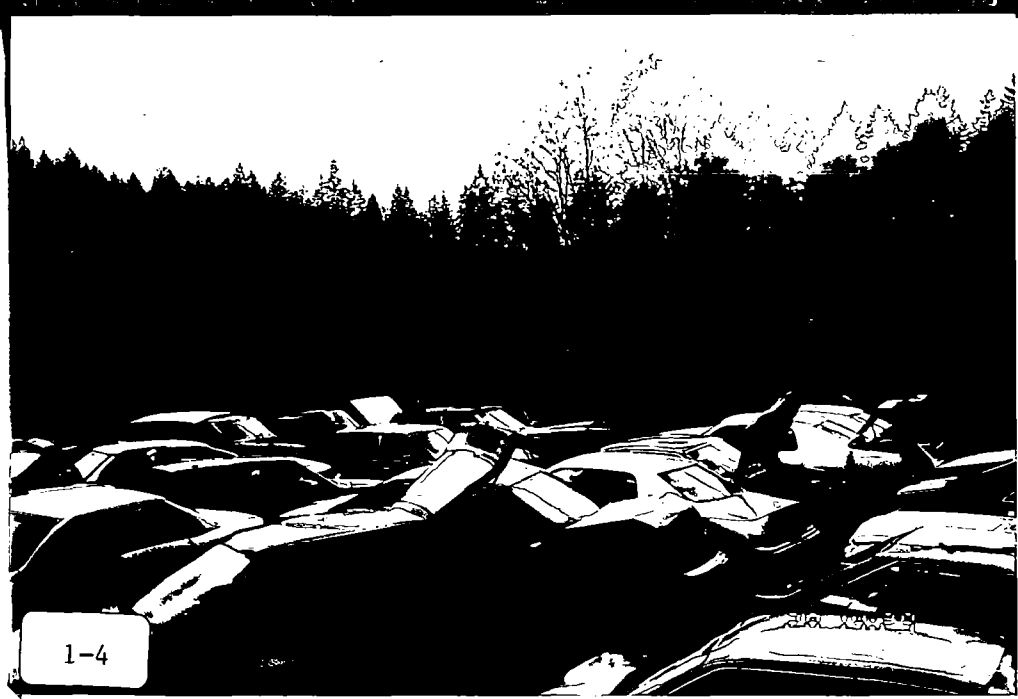
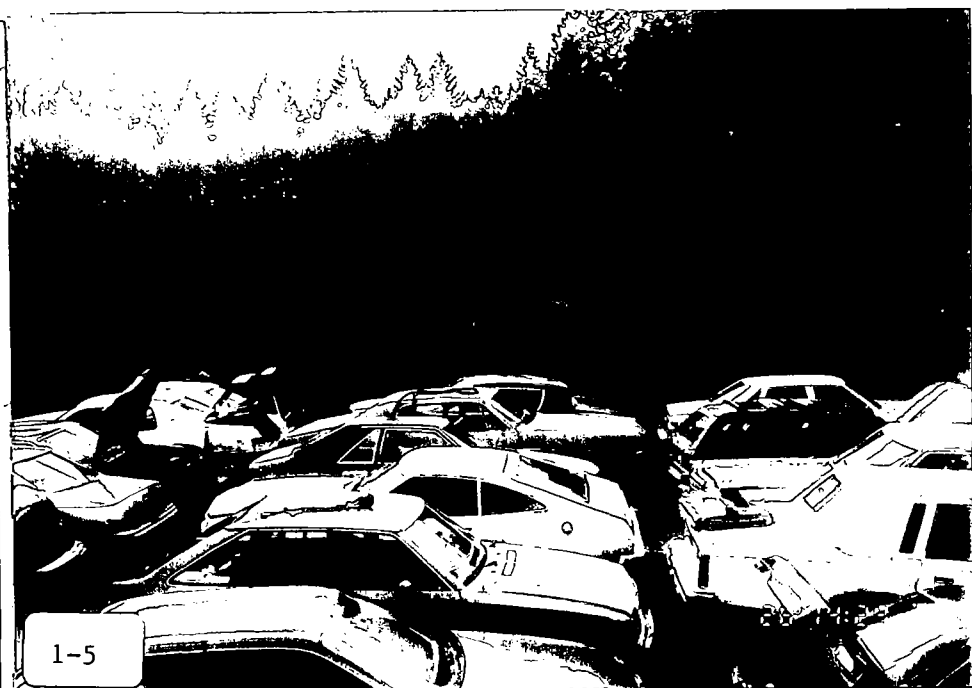
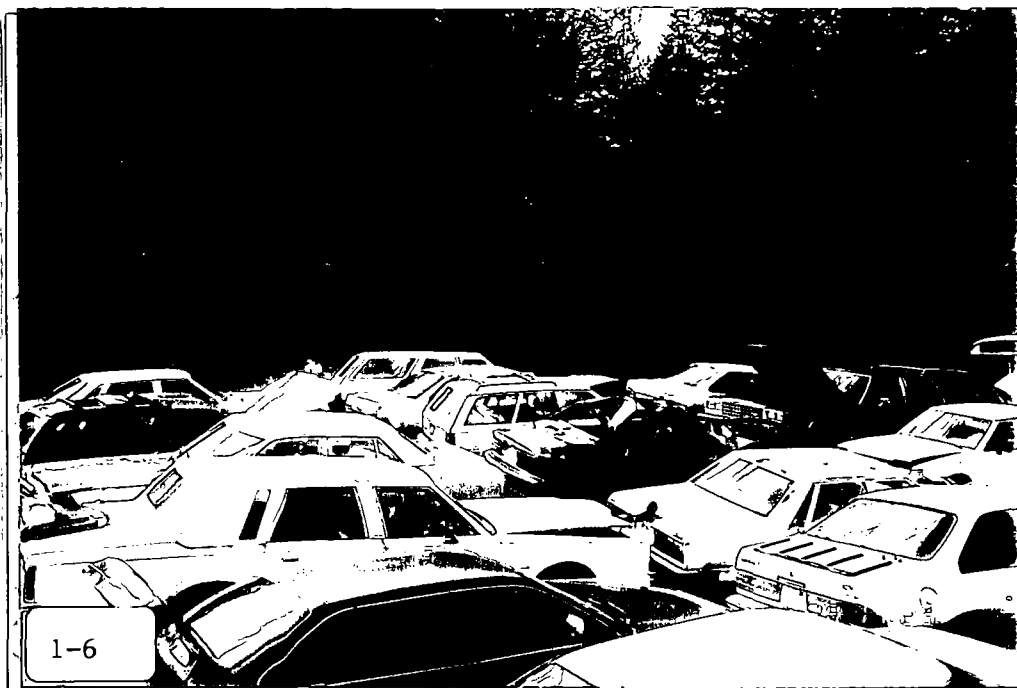
Currently, the Gorst Creek - Bremerton Auto Wrecking Landfill is covered with blackberry brambles (Appendix A; photographs 1-7 through 1-14). Based on the findings of the Site Hazard Assessment conducted by Hart Crowser in 2000, the contaminants of concern at the site include pesticides/polychlorinated biphenyls (pesticides/PCBs), semivolatile organic compounds (SVOCs), Target Analyte List metals, and volatile organic compounds (VOCs). The site is estimated to contain approximately 150,000 cubic yards of waste (Hart Crowser 2000).

Photo No.	Dir.	Date	Time	By	Description
1-1	W	01/28/03	1347	ML	Pond upstream side of landfill. Pond resulting from rainfall impounded in ravine, estimated 30 feet deep in center.
1-2	SW	01/28/03	1419	ML	Pond upstream side of landfill.
1-3	S	01/28/03	1429	ML	Panorama of landfill area taken from Airport Auto Wrecking Too. The landfill is the brush covered area.
1-4	SW	01/28/03	1429	ML	Panorama of landfill area taken from Airport Auto Wrecking, Too. The landfill is the brush covered area.
1-5	SW	01/28/03	1429	ML	Panorama of landfill area taken from Airport Auto Wrecking, Too. The landfill is the brush covered area.
1-6	W	01/28/03	1429	ML	Panorama of landfill area taken from Airport Auto Wrecking, Too. The landfill is the brush covered area.
1-7	N	01/28/03	1445	ML	Panorama of the landfill from the edge of the landfill. Taken from the adjacent property.
1-8	NE	01/28/03	1445	ML	Panorama of the landfill from the edge of the landfill. Taken from the adjacent property.
